INSTITUTE FOR THE ENVIRONMENT  
HIGHLANDS FIELD SITE  
2008 INTERNSHIP RESEARCH REPORTS

HIGHLANDS BIOLOGICAL STATION  
HIGHLANDS, NORTH CAROLINA

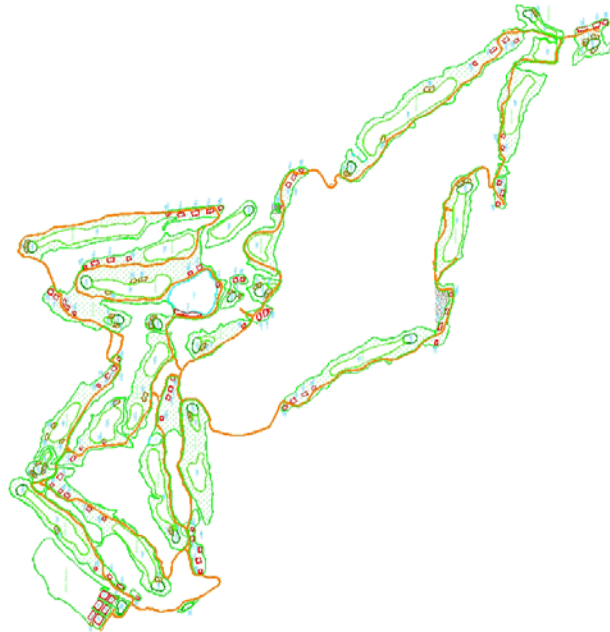
FIG. 2. Existing Cullasaja Club golf course map lacks coverage of river and most bodies of water.

One of the primary goals of this project was to enhance mapping of the Cullasaja Club golf course, to include information about the stream. Current maps of the course are strictly golf-centered and fail to map the water (Fig. 2). In order for the Club to begin planning for river restoration, they need to be able to quantify how many linear feet of the river exists on their property, the square footage of areas along the river bank, and what riparian zone plant species will suit the needs of both the river and the golf course. I enhanced the Cullasaja Club's map to provide detailed coverage of the Cullasaja River, conducted analysis of current stream bank conditions, and provide comprehensive recommendations for a riparian buffer zone plan. My recommendations are intended, in part, to serve as an interim buffer zone strategy until the implementation of a future stream restoration project. A portion of the recommendations have the potential to be immediately incorporated into the long-term maintenance plan, while other recommendations involve areas of the stream where extensive restructuring of the bank is

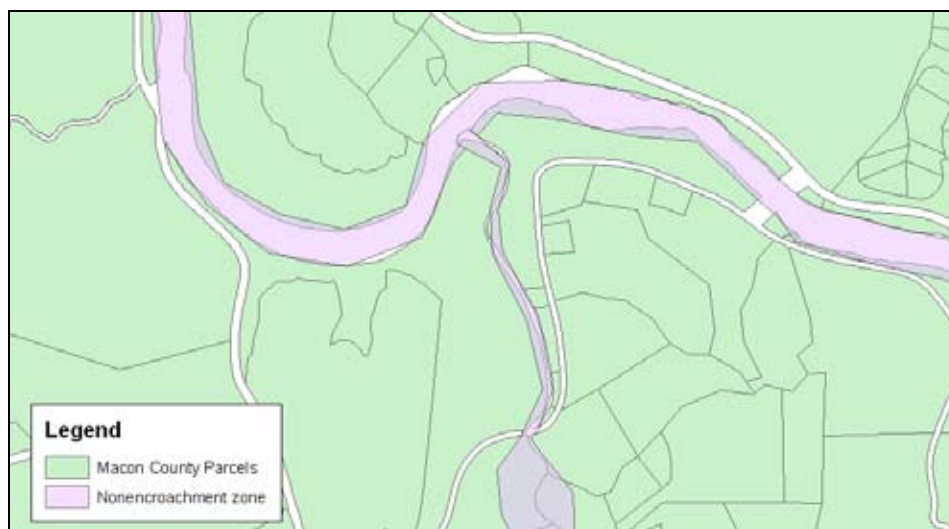
FIG. 2. An example of Macon County parcel data showing the non-encroachment area.

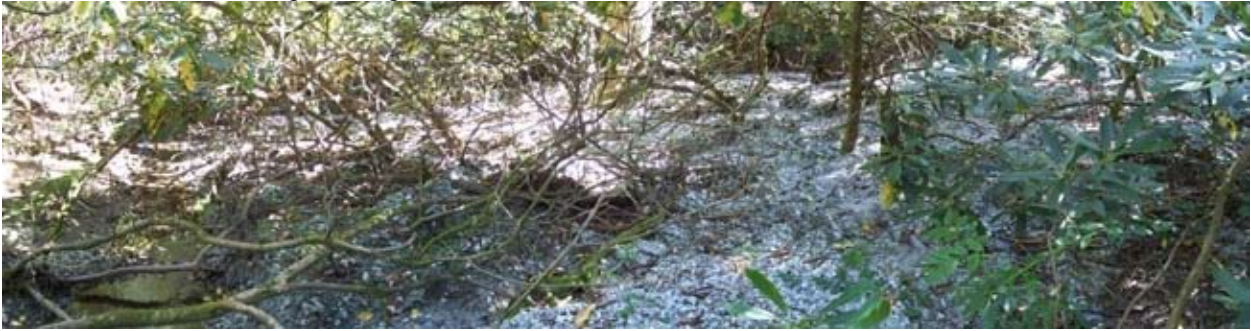
Mill Creek where it meets the crushed stone deposit directly below Sunset Rock Road at station 2395.

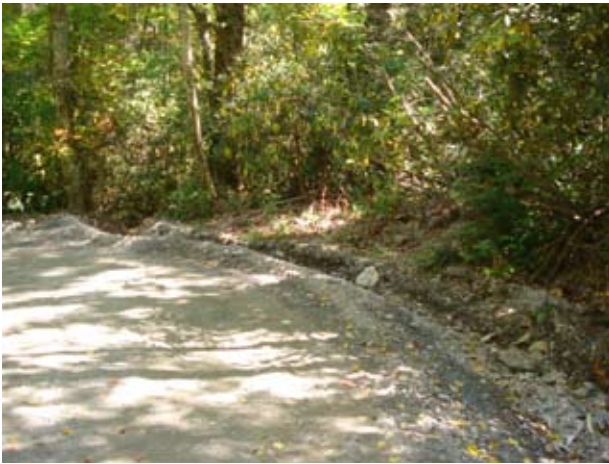
An erosional channel beside Sunset Rock Road at station 2130 before implementation of water and sediment control practices.

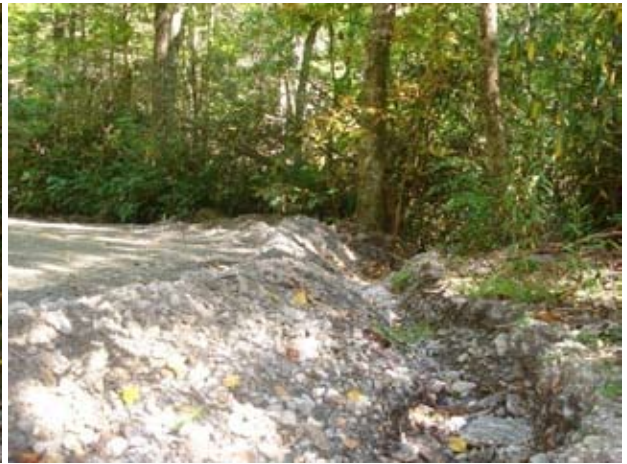
A closer look at the erosional channel at station 2130.

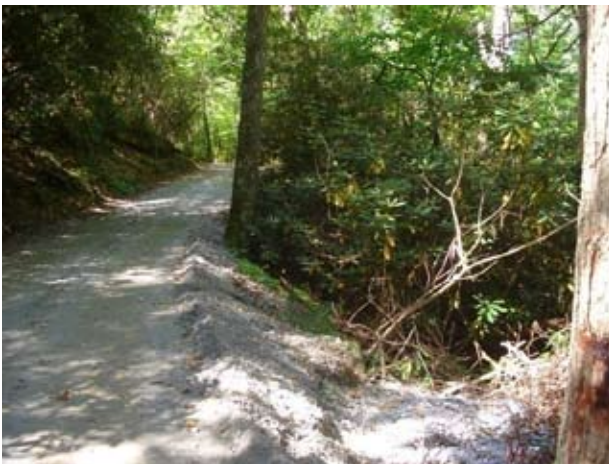
Station 2395 before implementation of water and sediment control structures.

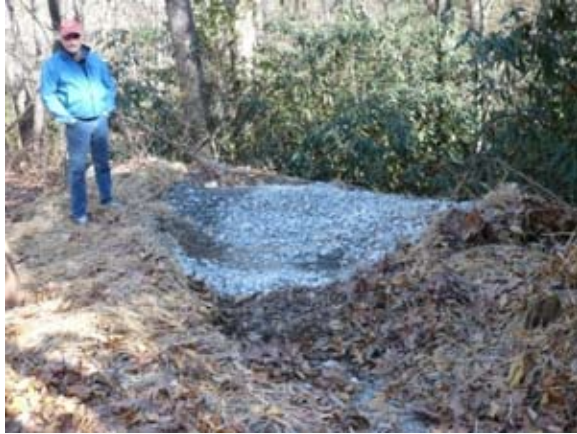
#### Station 145

Sediment trap at station 145 appears reasonably sized for the amount of deposition that can be expected at this elevation and slope.

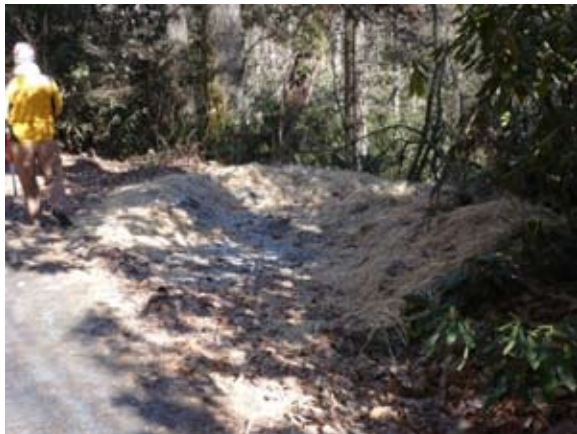
#### Station 315

Sediment trap at station 315 is located in an area where storm water is conveyed by sheet flow along the surface of the roadway and therefore this trap may not provide much remediation.

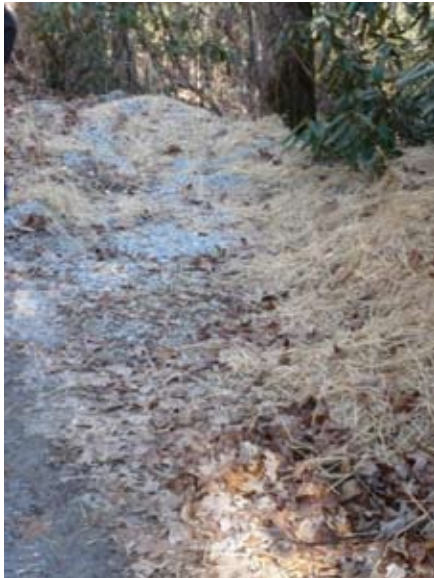
#### **Station 390**

Sediment trap at station 390 is located, similar to the previous trap, in an area where waters appears in sheet flow with little discrete conveyance of stormwater.

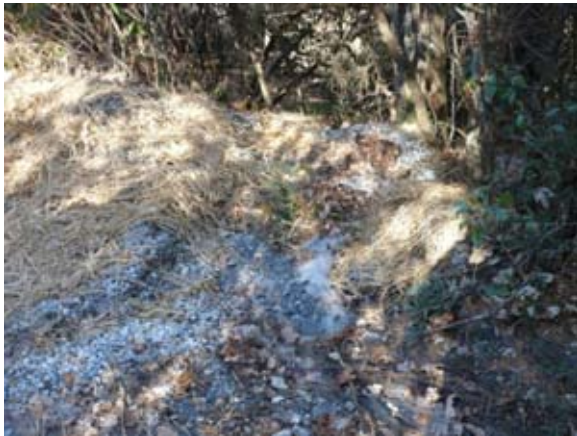
#### **Station 1335**

Sediment trap at station 1335 is placed just up-slope of an area of discrete conveyance and therefore has the potential to intercept some discharge and sediment transport before it reaches said area of discrete conveyance.

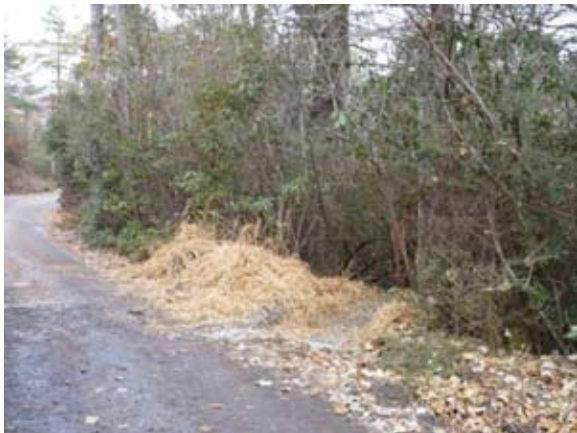
#### **Station 1575**

Sediment trap at station 1575 appears well placed to intercept significant discharge and sediment transport. However, after the first rain event since its construction (a small rain event the weekend of November 14-16), this trap has begun to allow sediment to pass through the system and be transported downslope. This structure may benefit from an expansion of width and depth as well as reinforcement with larger stone.

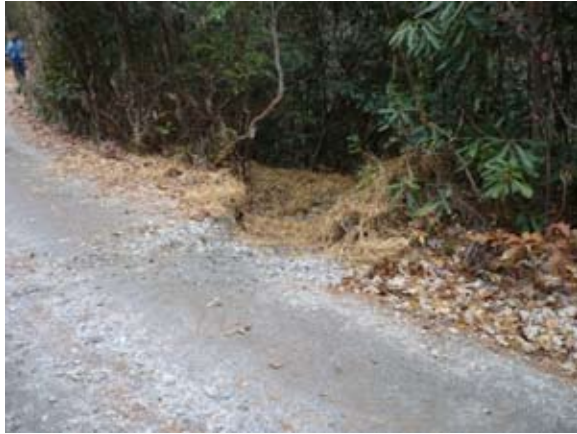
#### **Station 1630**

Sediment trap at station 1630 appears well placed and reasonably sized for the drainage area it serves. This structure may benefit from reinforcement with larger stone.

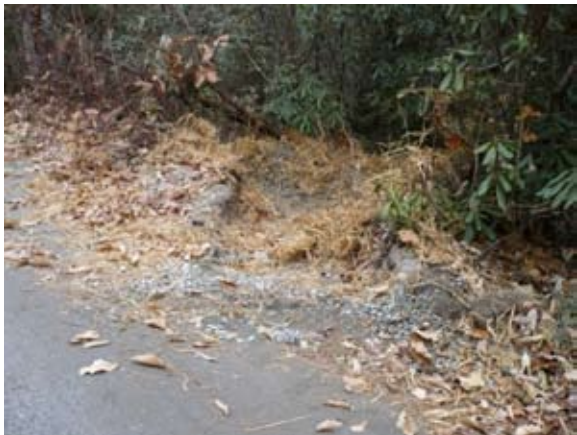
#### **Station 1685**

Sediment trap at station 1685 appears well placed, occurring before the grade of the road shifts to the other side in the curve. The wing ditch at the entrance to the sediment trap is partially blocked. Its functionality would likely be improved if the entrance was smoothed and leveled to promote discharge of stormwater into the structure.

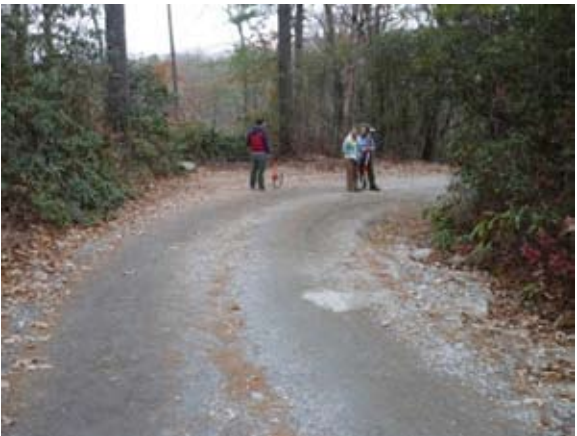
#### **Station 1800**

There is currently no sediment control structure here. The slope of the road directly above this location has steepened and the location is just prior to the initiation of a sharp curve where there is evidence of significant discharge. Recommendations for this location include an angled culvert to divert water across the road from right to left (orient facing down slope/down road) with a sediment trap on the left where the culvert would discharge. An alternate suggestion is to regrade the road to slope toward the outside of the curve and then construct a sediment trap to capture the redirected flow.

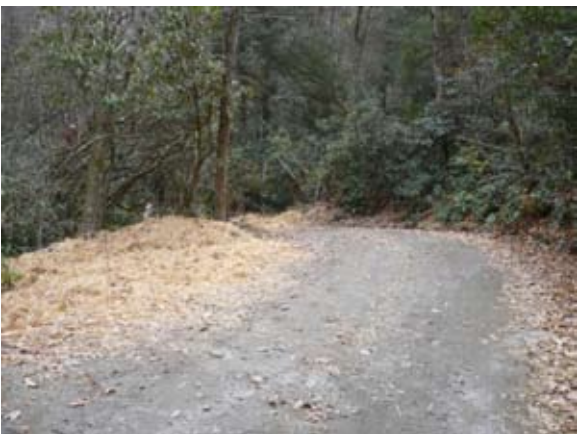
#### **Station 2060**

Sediment trap at station 2060 would be more beneficial if a culvert or water bar was added to bring water across the road. Current conditions of the road grade appear to prevent proper functioning of this system since the trap does not appear to intercept flow.

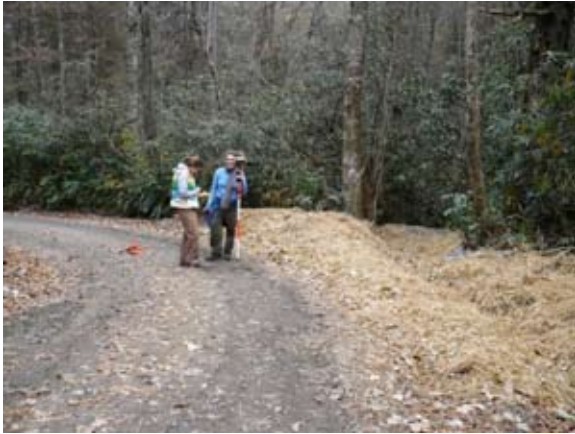
#### **Station 2130**

Sediment trap at station 2130 appears well placed to intercept a significant amount of discharge and sediment as evidenced by significant deposition as a result of the first small rain event since construction. This structure would likely benefit from an expansion of width and depth as well as reinforcement with larger stone. Its location in an area of significant drainage suggests that this trap should be part of a diligent, routine inspection and maintenance plan to avoid exceeding the capacity of the system.

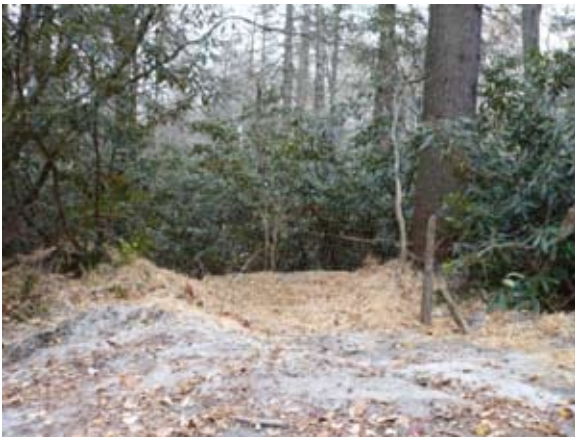
#### **Station 2330**

Sediment trap at station 2330 appears well placed and the cross-road barrier is working to divert flow into the trap. In a storm event however, the barrier appears insufficient to prevent water from bypassing this station.

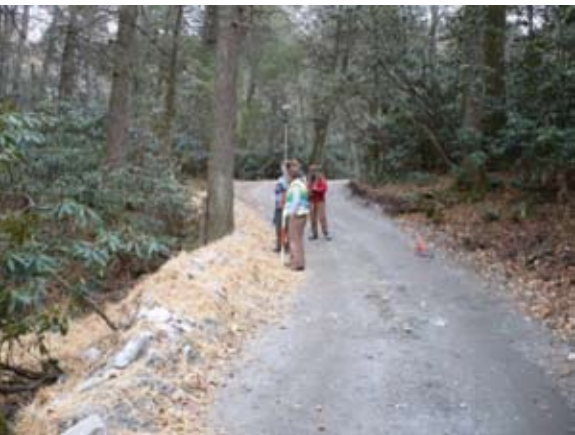
#### **Station 2395**

This station is located at the primary point of crushed stone transport into the stream below. The street department has created a barrier of crushed stone and some larger stone along the edge of the road here. Due to the construction of a number of sediment traps up-slope from this site, having no outlet to divert water from the road surface here may function well in interruption of sediment transport. This site should be inspected after the next big rain event to determine the success of the barrier and if the addition of a sediment trap or alternative remediation strategy would be beneficial.

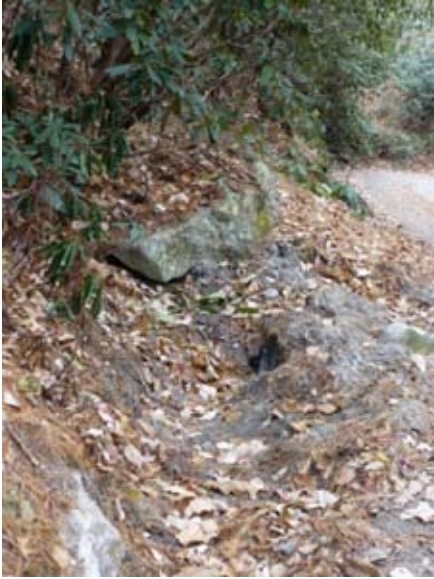
#### **Station 2761**

Sediment trap at station 2761 intercepts the discharge of a culvert. Routine clearing of the culvert is suggested for maintaining the success of this trap.

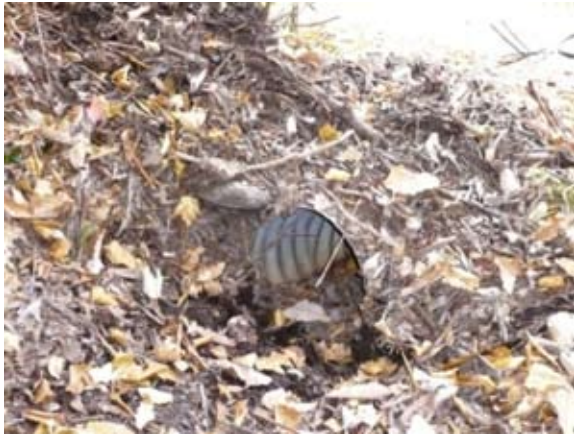
#### **Station 2830**

This is the location of a culvert that intercepts discharge from the left side of the road. As recommended for all other culverts on the road, routine clearing of the culvert is necessary for the success of this feature. The sediment trap on the right side of the road may benefit from be lined with larger stone. This station would likely benefit from the construction of wing ditch on the right side of the road to intercept discharge from the right side of the road. The wing ditch could utilize the same sediment trap as the culvert discharge.

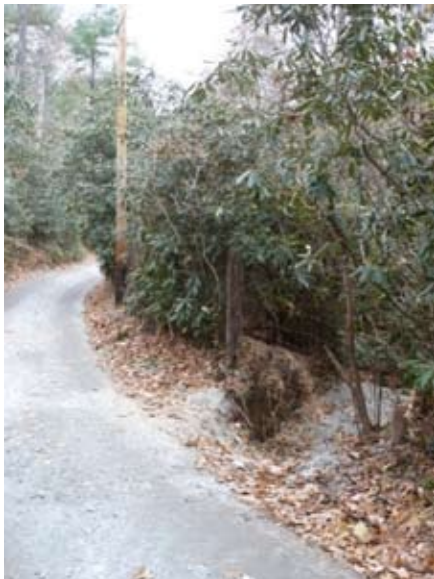
#### **Station 2880**

Sediment trap at station 2880 appears well placed to transport water from the ephemeral channel entering the road from the left and passing under the road in a culvert. Routine clearing of the culvert is necessary for the success of this feature. The trap may benefit from an expansion of width and depth as well as reinforcement with larger stone. A low spot at the rear of the trap was eroded to form a gap after the first rain event since construction.

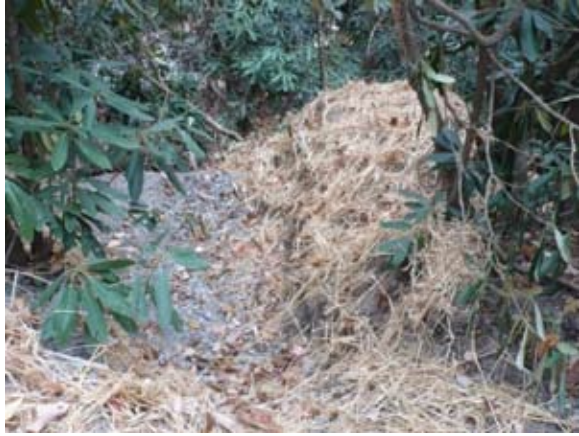
### **Station 3010**

Sediment trap at station 3010 appears to be intercepting discharge fairly well. The steep entry may lead discharge to erode and cut into the road. The trap may benefit from reinforcement with larger stone.
